Performance of Uncoated AFRSI Blankets during Multiple Space Shuttle Flights

Paul M. Sawko and Howard E. Goldstein

April 1992

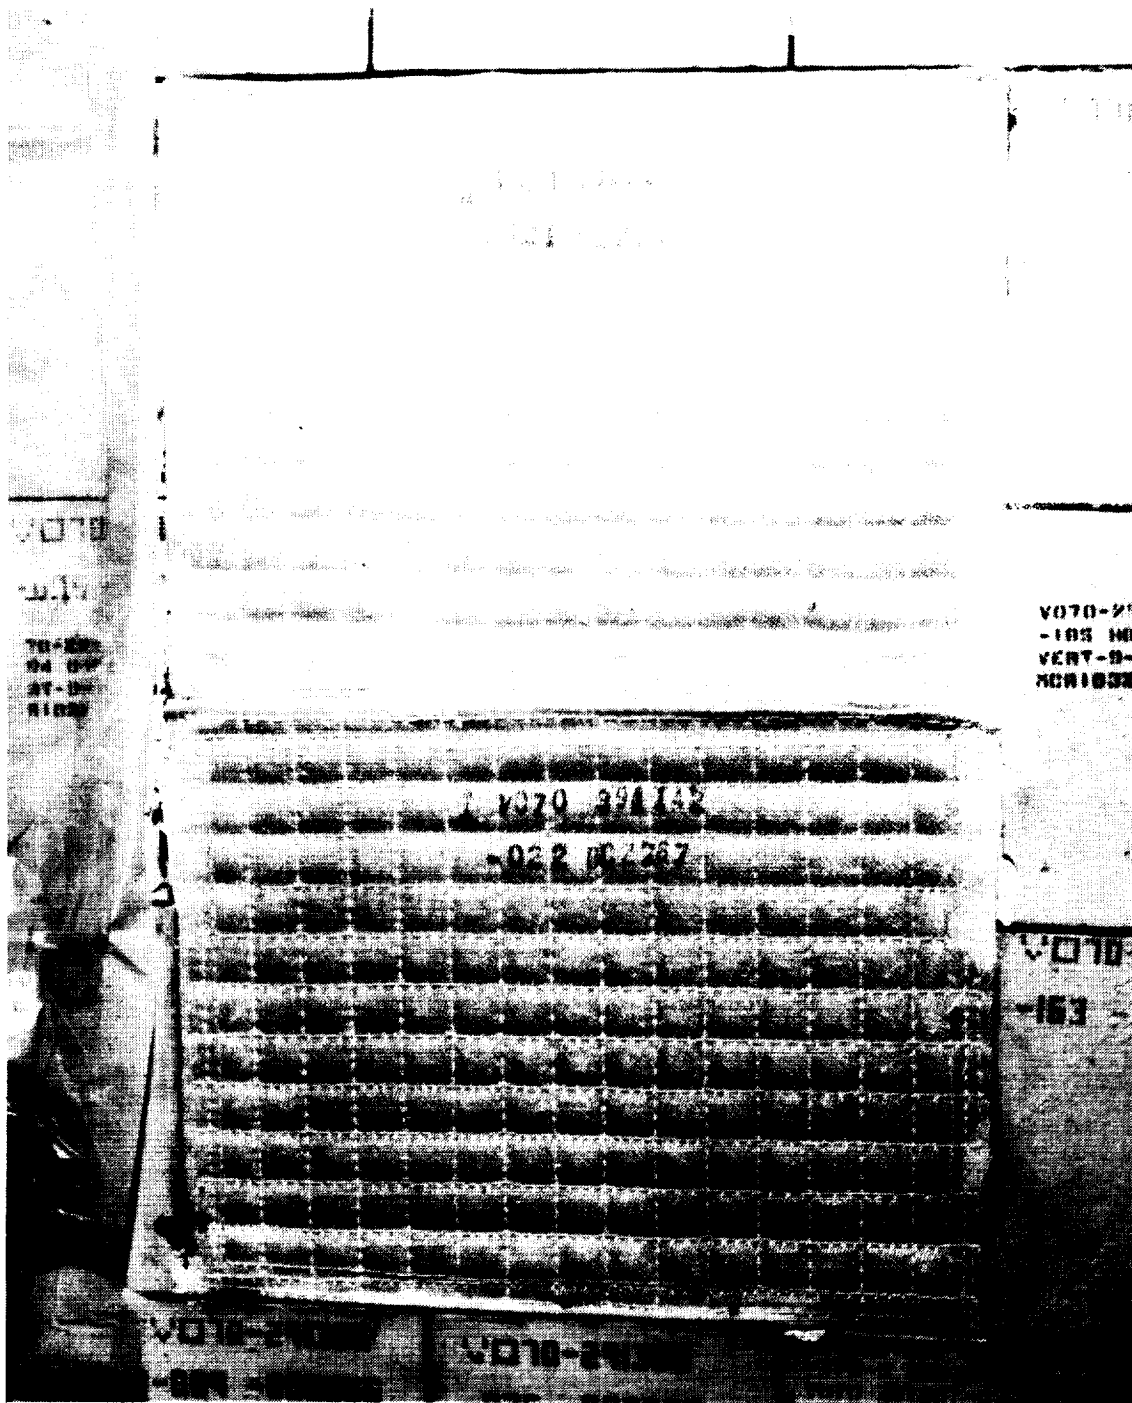
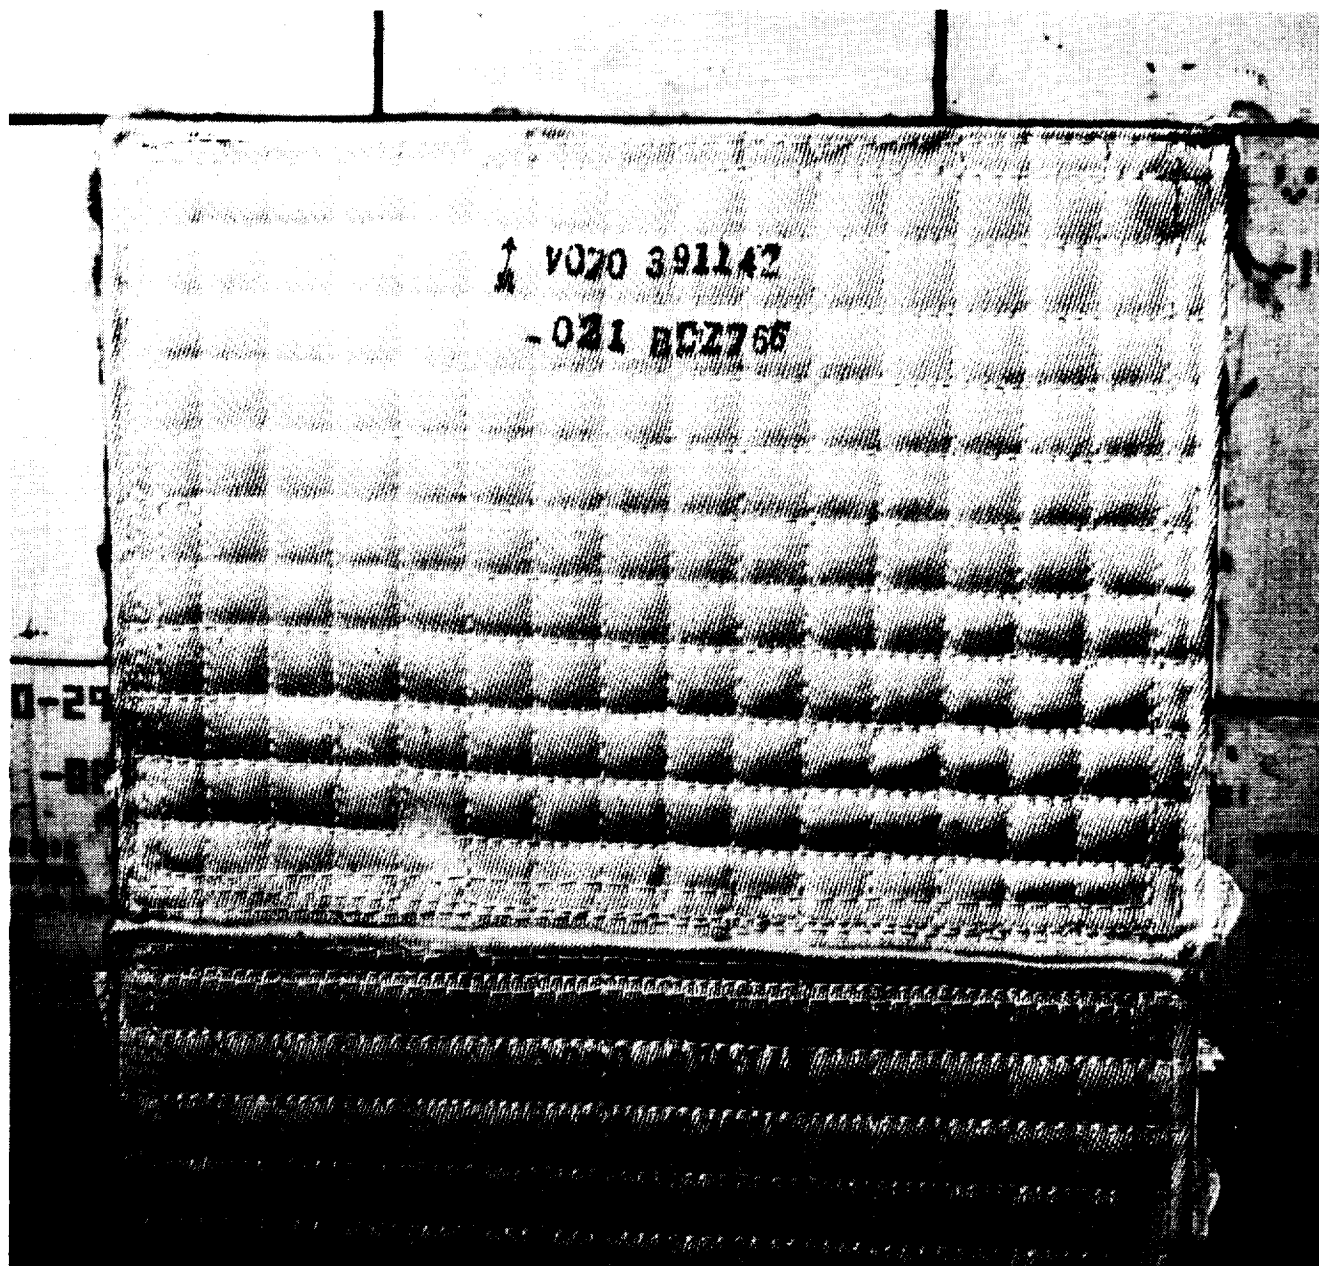
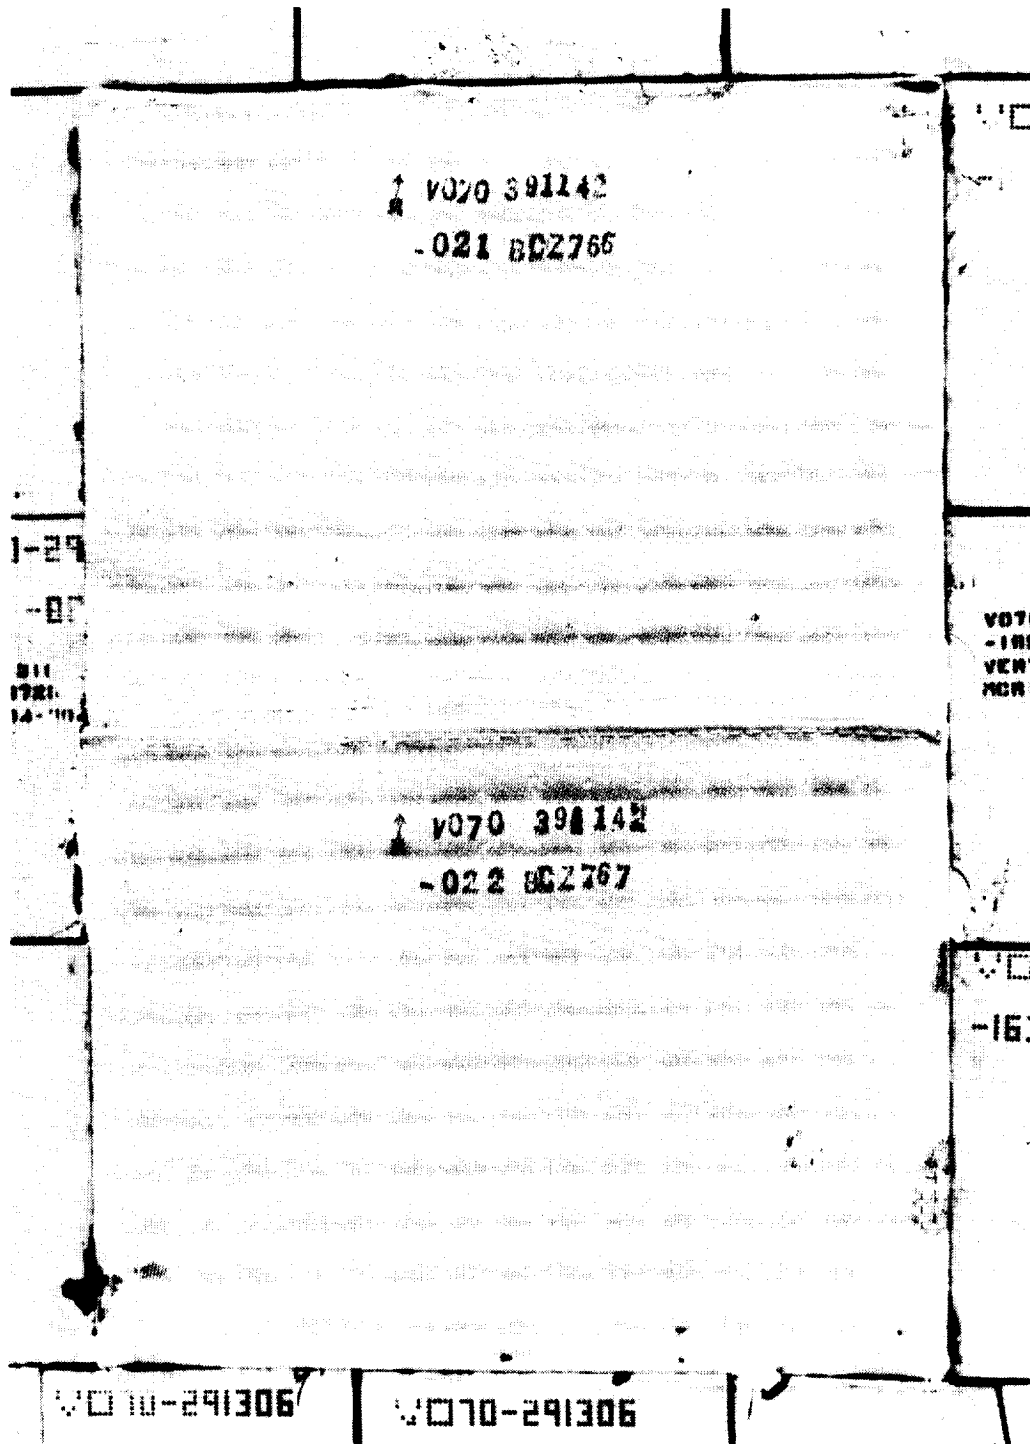
Figure 8. Vertical tail location, Flight 61A.

After Flight 61A, the first flight of the newly installed blankets, no new damage was visible (table 6), although some minor discoloration was present at the leading edge of Blanket 391142-021 and the upper edge of Blanket 391142-028. The blankets were discolored because the silicone adhesive used during the installation process (RTV 560) was exposed to a peak reentry temperature of 888° F. This discoloration is seen in the photographs taken after the landing at DFRF (fig. 8(a)) and the return to KSC (fig. 8(b)), which revealed no damage other than the discoloration described when compared with the preflight photograph (fig. 8(c)).

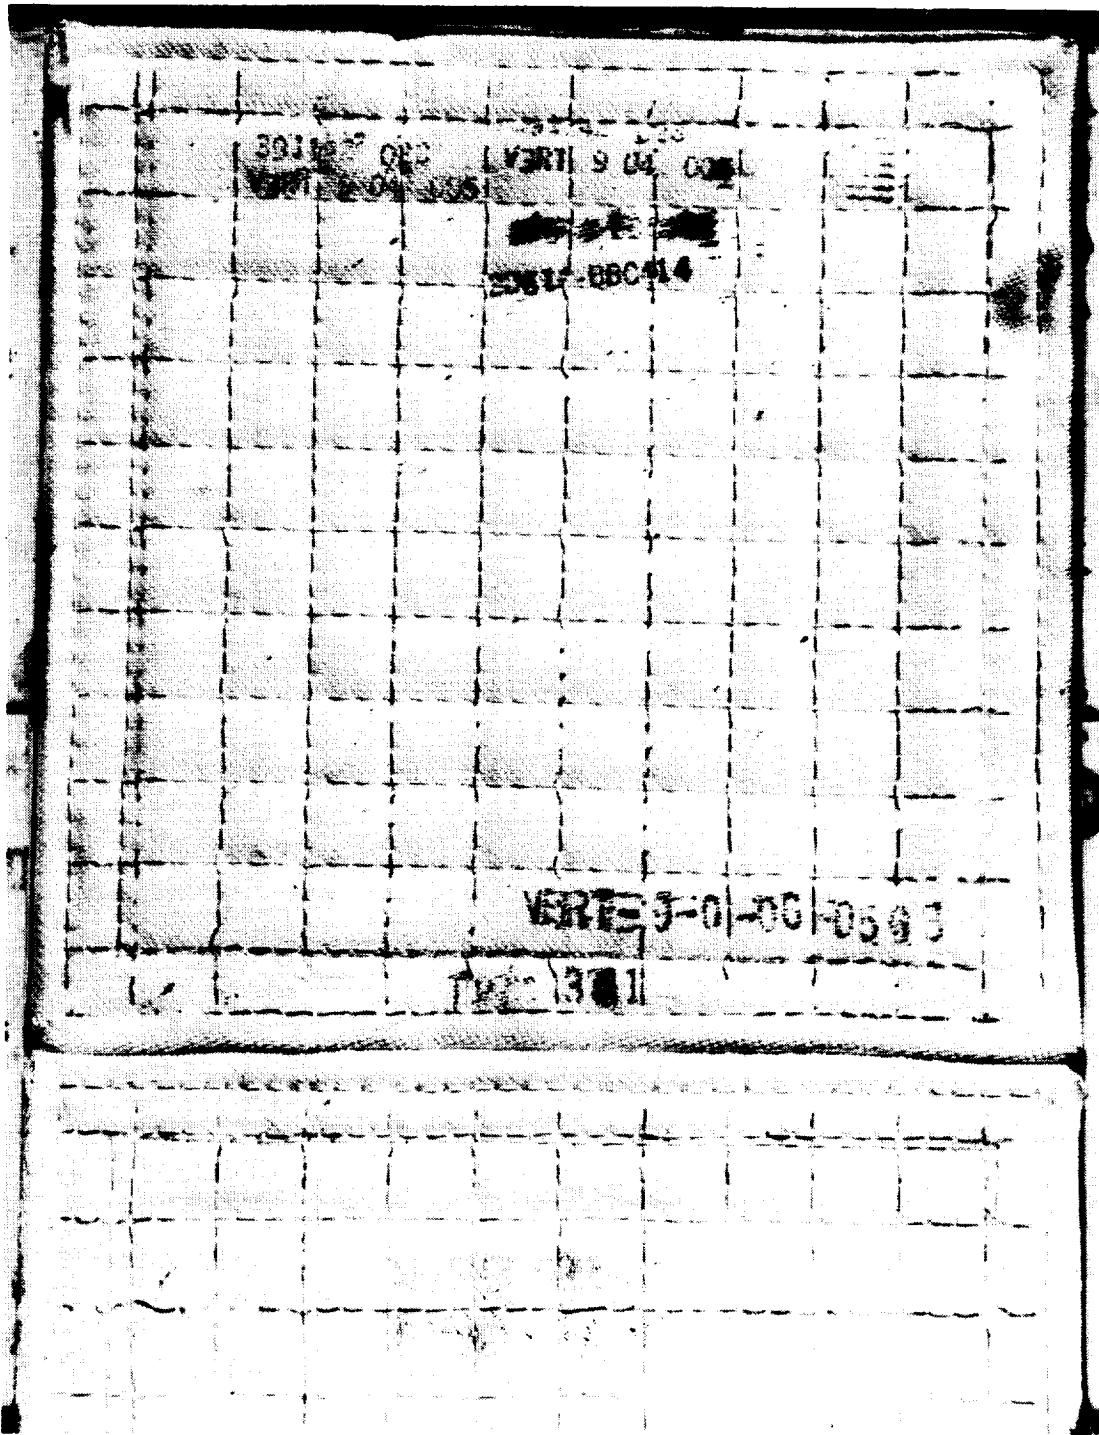
Figure 9. Continued.

Initially, two uncoated AFRSI blankets were positioned at this location. After STS-8, no data were reported for either blanket (table 3). After the next flight, 41B, the damage inspection showed a small tear in the OML fabric along with several broken stitches for Blanket 391142-023. The other test blanket, 391142-024, was C-9 coated because of overall damage to the surface in the form of broken threads and frayed fabric, so no further performance data were collected for this blanket. No new damage was noticed for Blanket 391142-023 after Flights 41C and 41G. After Flight 51B, there were no new broken stitches, although some pillowing and insulation (felt) movement at both the leading and trailing edges were observed. No surface discoloration had occurred. Damage inspection after Flight 51F showed no proliferation of broken threads, no discoloration, and no change in the degree of distortion from the previous flight. The Flight 61A inspection revealed a slightly frayed corner at the lower forward edge in addition to the original thread breakage. Some black coloring of the sewing threads was noticed. No further change in original distortion was apparent. The overall condition of the remaining uncoated AFRSI blanket was excellent. Again, a preflight photograph was taken prior to Flight 61A (fig. 9(a)), and post-flight photographs were taken at DFRF and KSC (figs. 9(b) and 9(c), respectively).
